PRELIMINARY ASSESSMENT

Southern Pacific Transportation Company

1301 E. Harrison Avenue

August, 29 1990

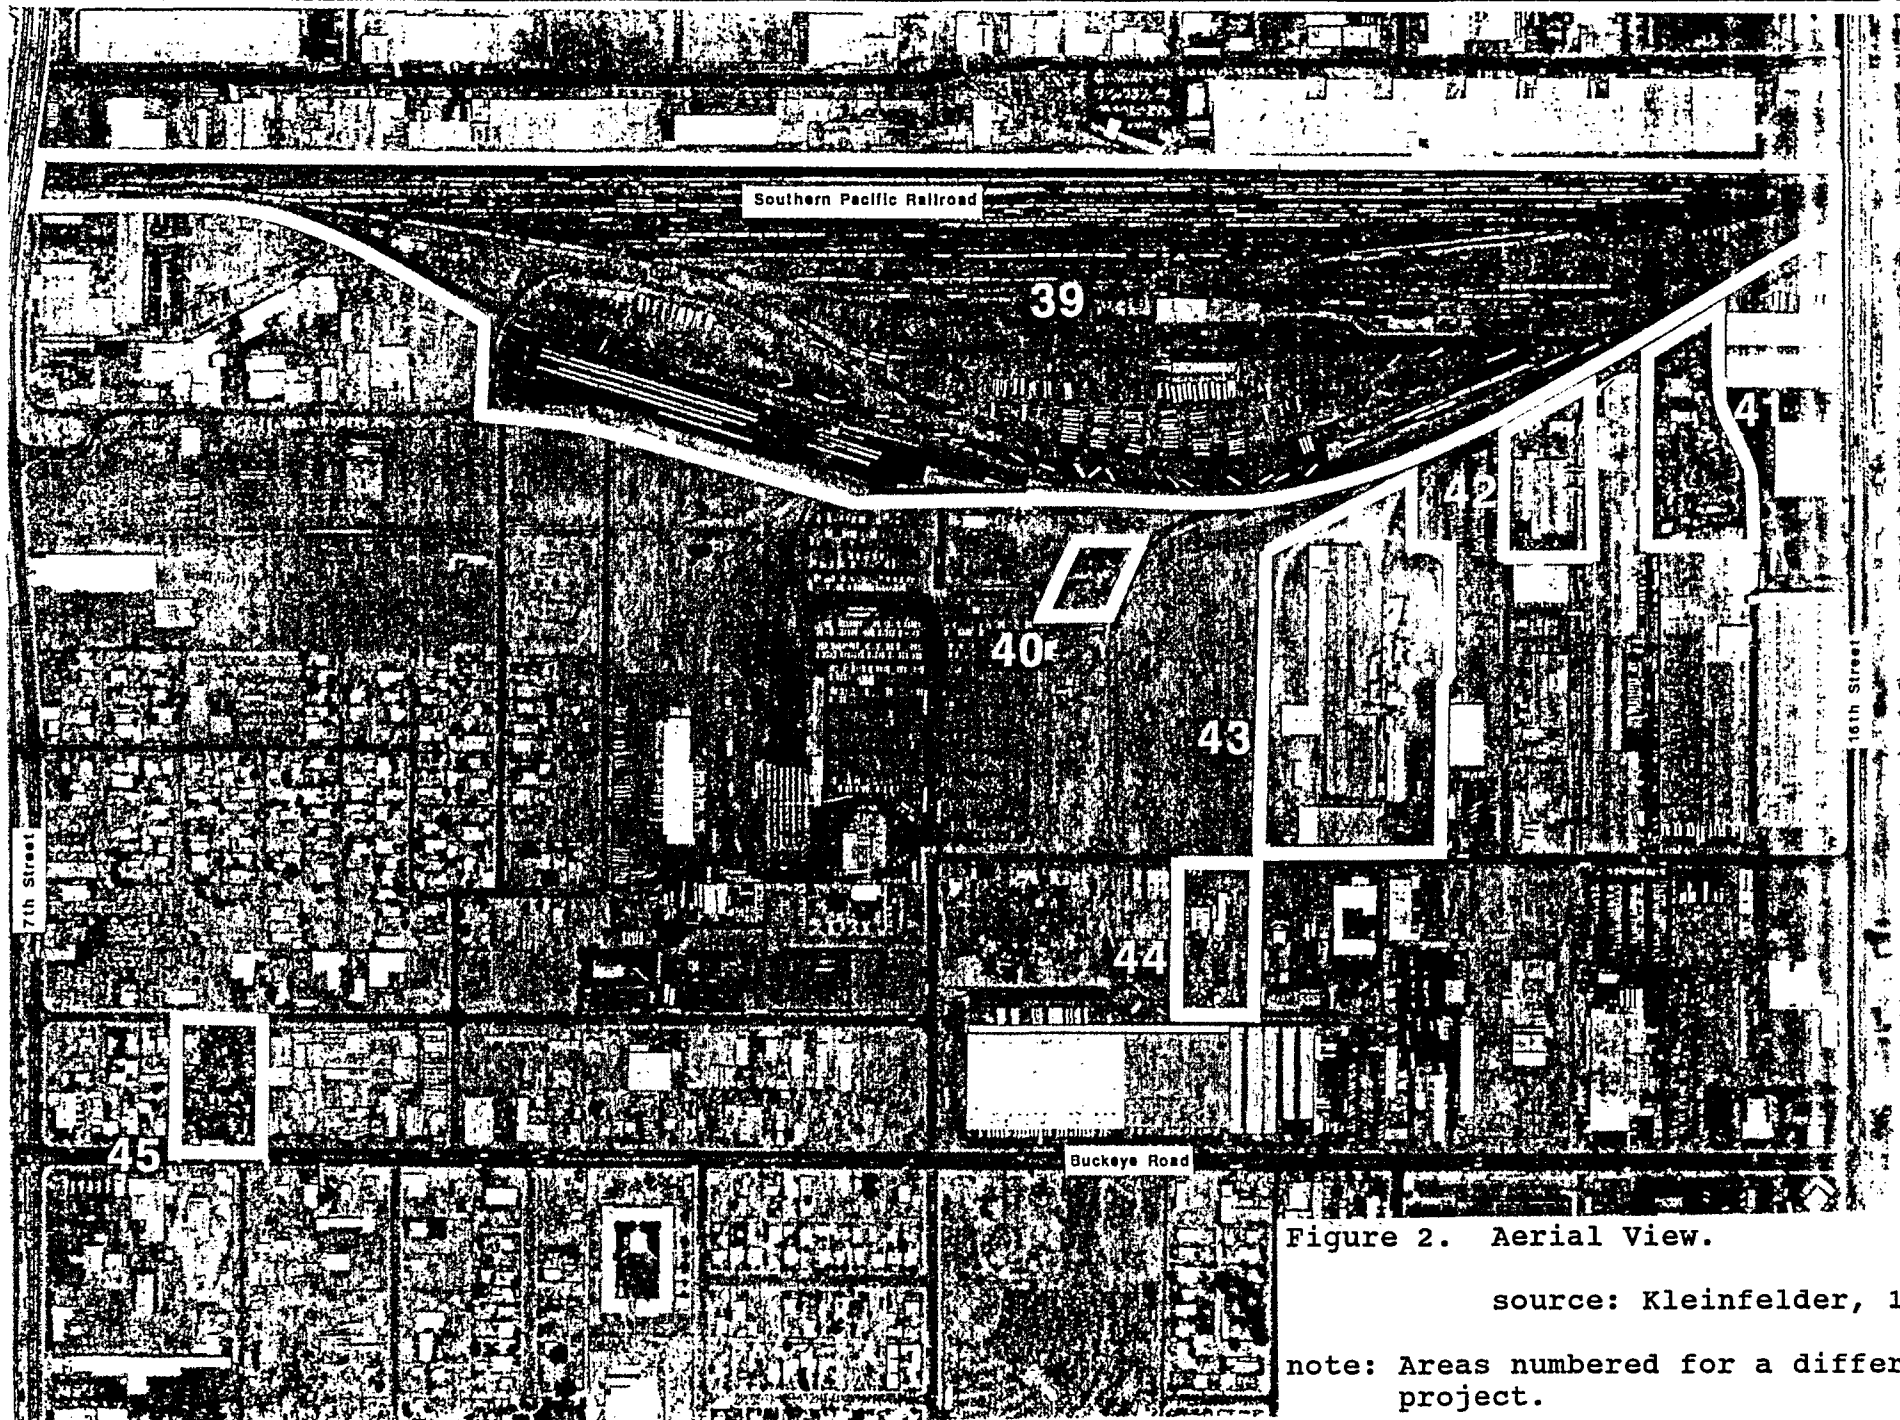
Figure 2. Aerial View.

Figure 1 shows the location of the site in Phoenix (3) and Figure 2 is an aerial view of the facility.(4) In the aerial view, the southern boundaries of the facility are difficult to discern. The southern boundary is an assortment of businesses and undeveloped areas. The northern boundary of the site is a row of businesses along Jackson Avenue. These businesses include The Tube Service Company, Tiernay Turbines, Farm Fresh Foods, Cash for Cans, Bralco Metals, Corbin Service and Electric, Pitton Industries, and Desert Fresh Foods.(5) The eastern boundary is 16th Street, and 9th Street is to the west.

Acreage is estimated from the aerial view (4) at approximately 82 acres. The site is approximately one mile long. The width of the site varies from 150 feet on either end to 1,000 feet in the middle. The area containing the site is zoned for heavy industrial

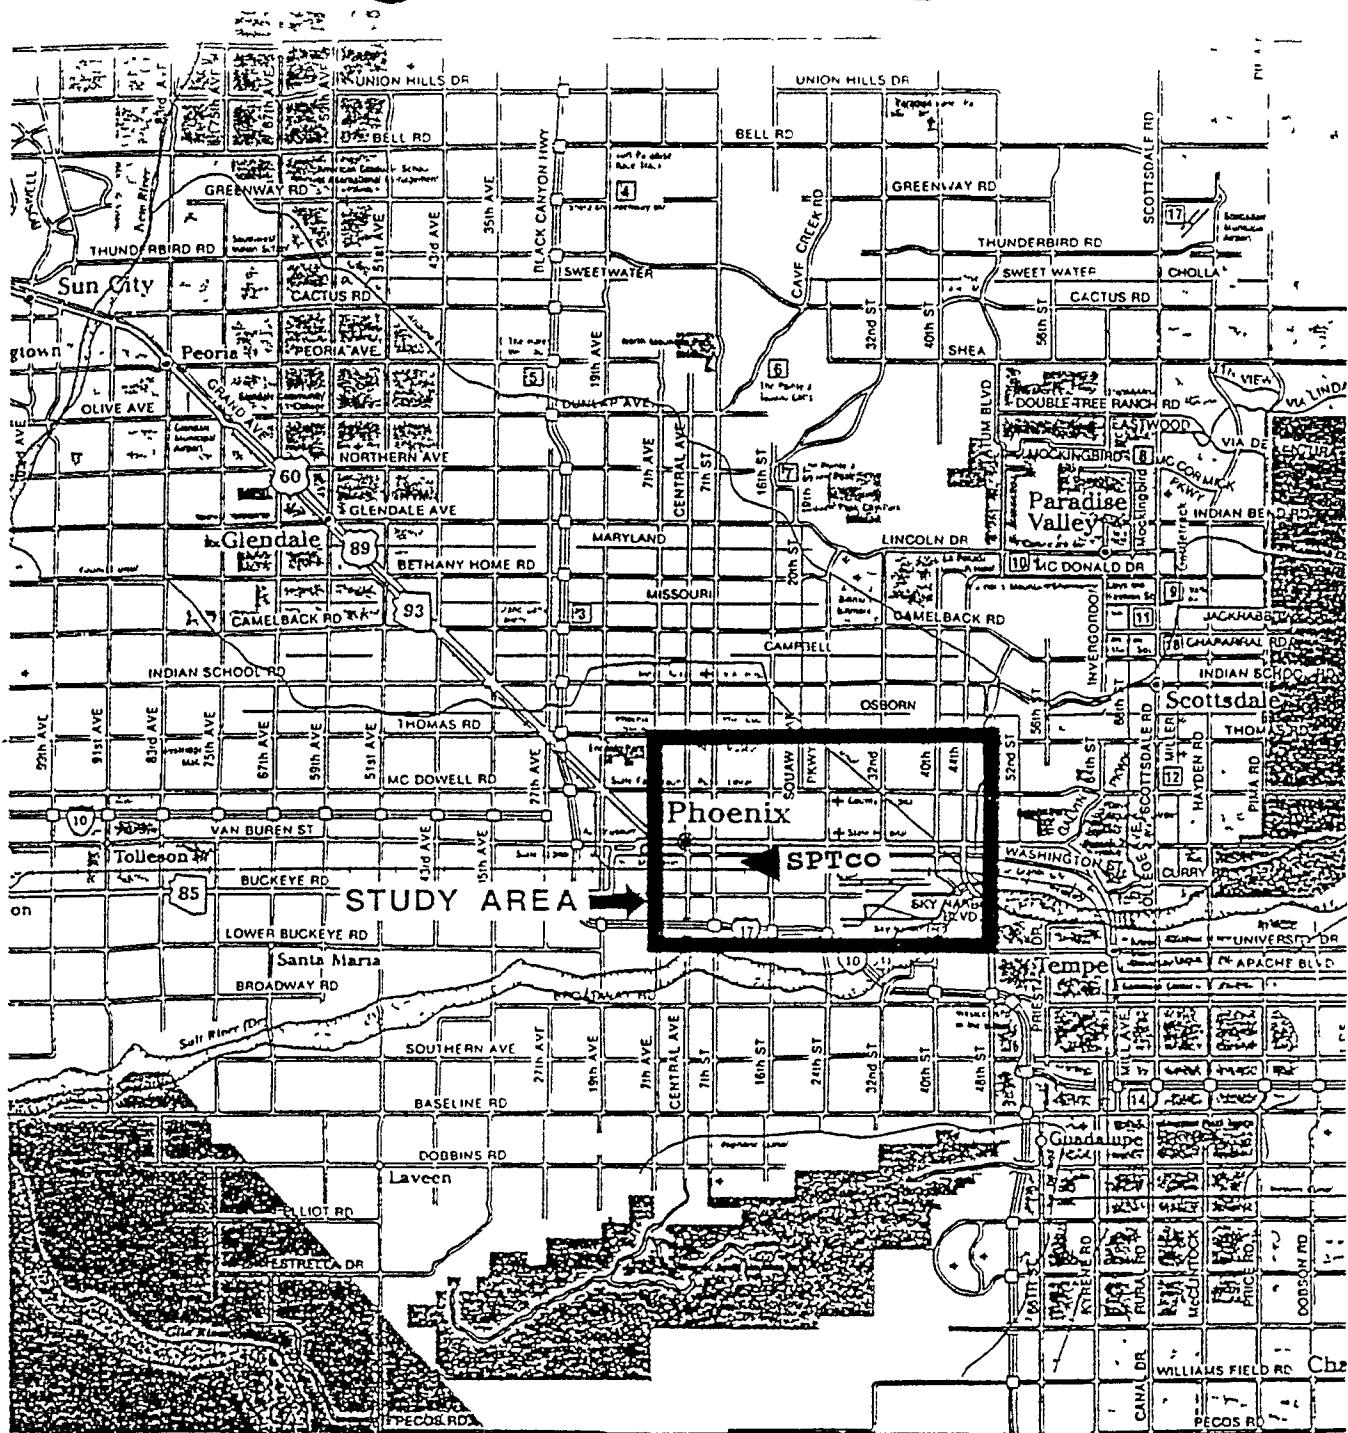
Figure 3. WQARF East Washington Area.

The site is located in the southern region of the East Washington WQARF Study Area approximately 2000 feet south of the Eastlake Park irrigation well. Figure 3 shows the location of the SPTco site within the East Washington Study Area.

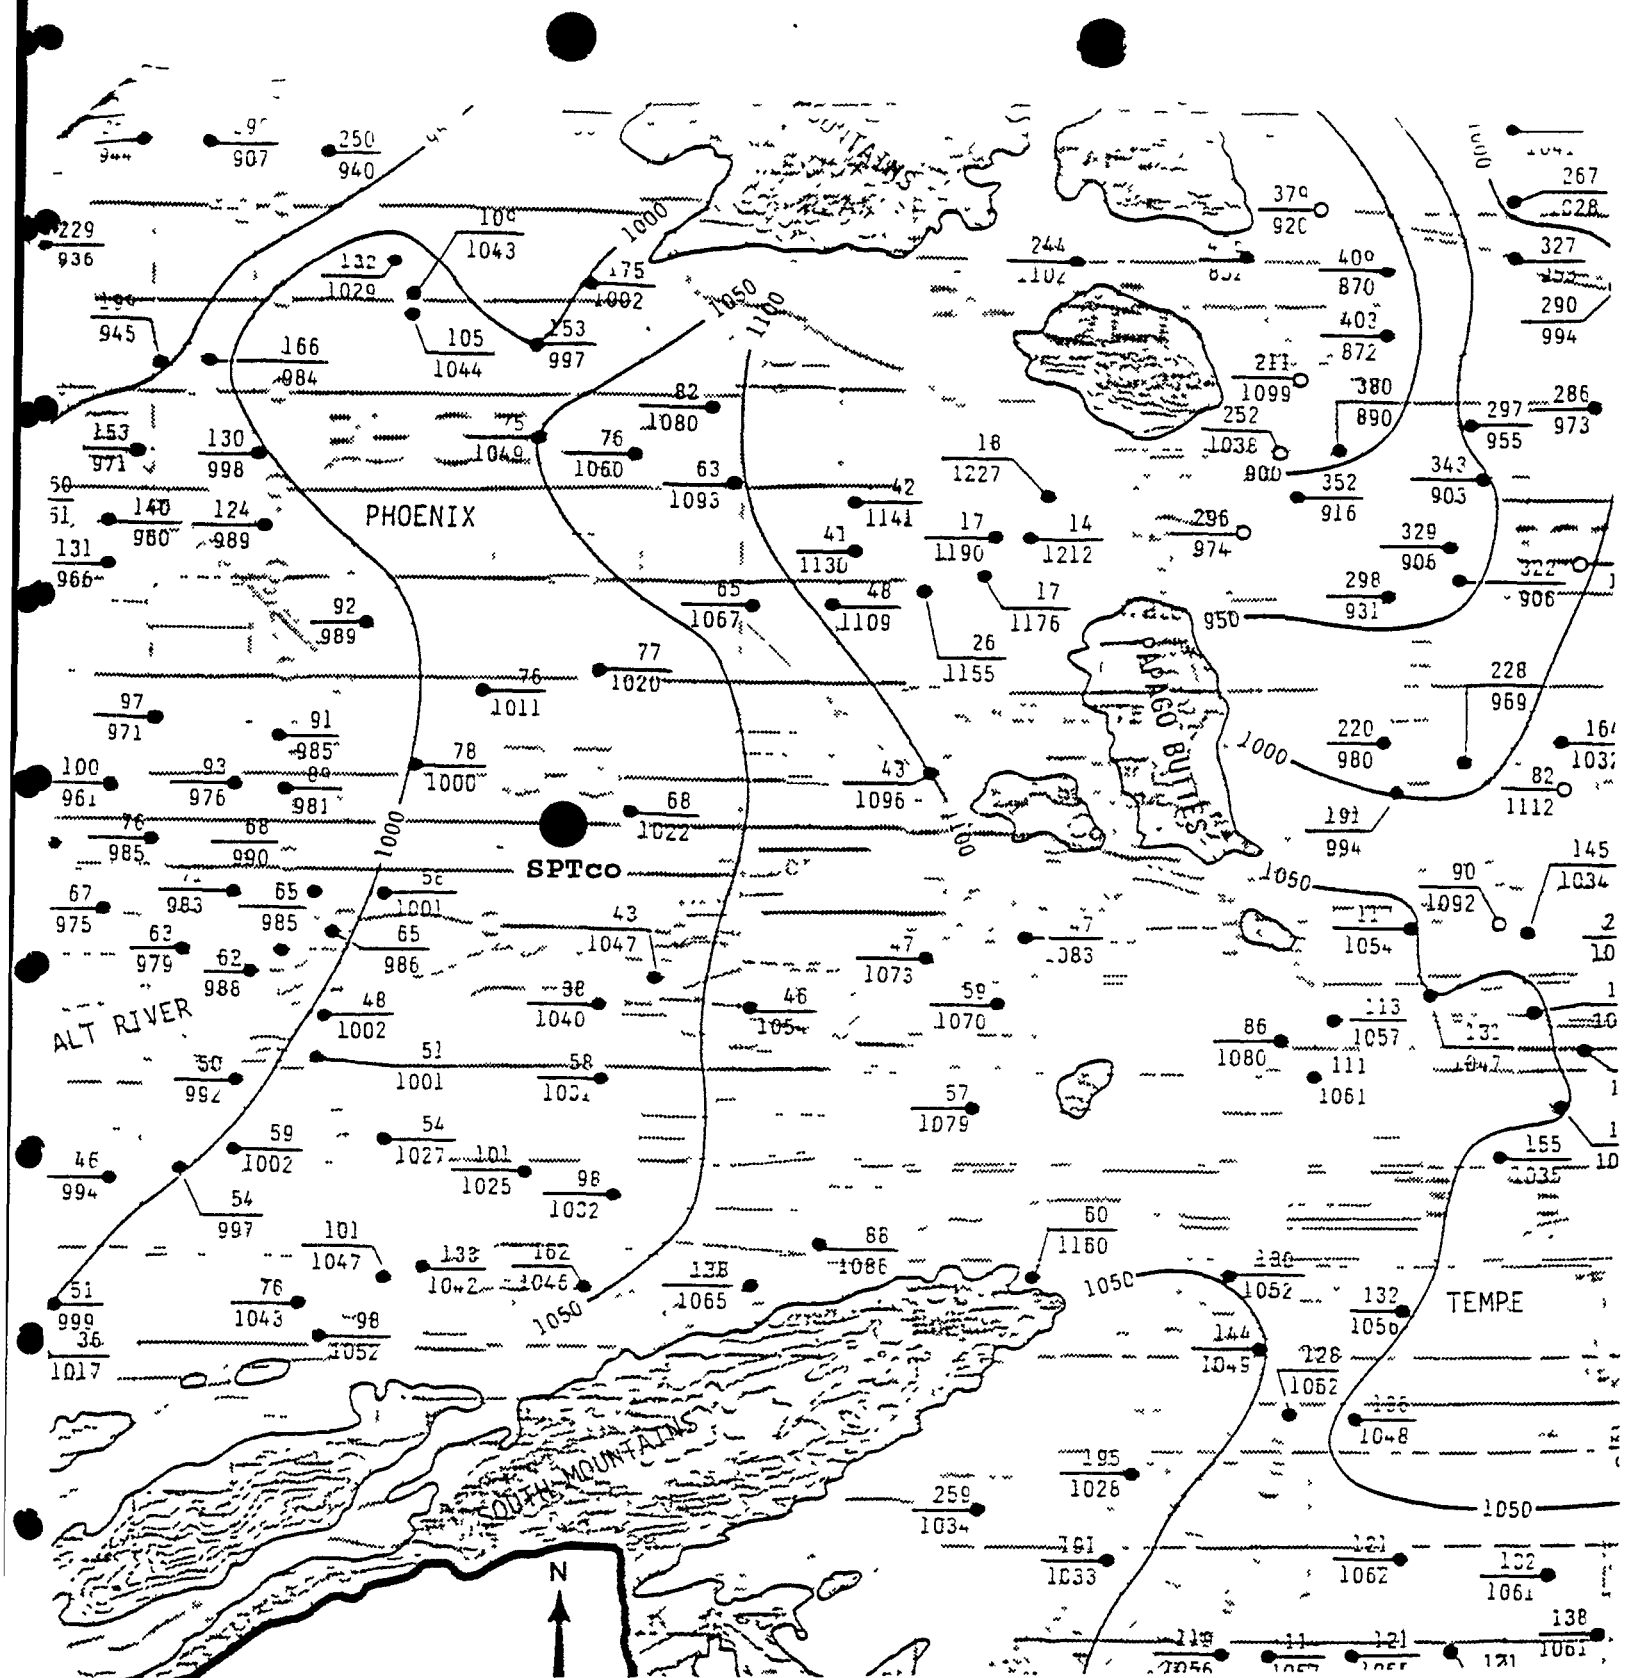
FIGURE 4 DEPTH TO GROUNDWATER AND WATER ELEVATION

Groundwater flow is generally to the west.(11) Figure 4 shows depth to groundwater is approximately 70 feet in the area of the site.(15) The specific conductance of area groundwater ranges from 950 micromhos/cm to 2050 micromhos/cm.(15)
